Effect of Rubberised Engineered Cementitious Composite (R-ECC) Application as Retrofitting Material on the Structural of Reinforced Concrete Beam-Column Joint Subjected to Static and Cyclic Loading

Nor Wahida Azmin, Mohd Ikmal Fazlan Rozli@Rosli, Kay Dora Abd Ghani, Atiqah Abdul Aziz, Noorliyana Zakaria, Nor Asyiqin Jafri

Centre for Civil Engineering Studies, University Technology MARA (UiTM), Cawangan Pulau Pinang, 13500 Permatang Pau, Pulau Pinang Malaysia
Corresponding Author Email: ikmal601@uitm.edu.my

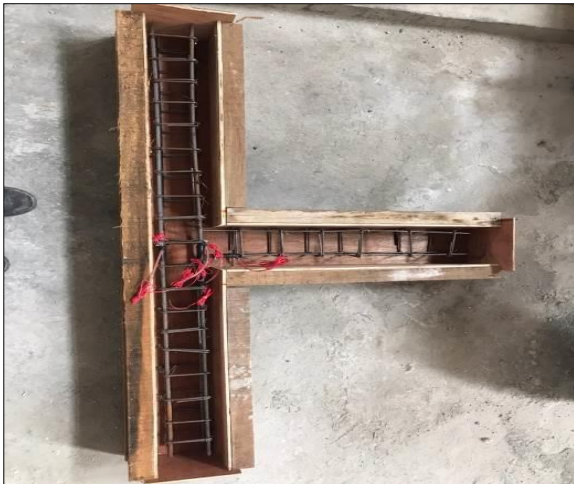
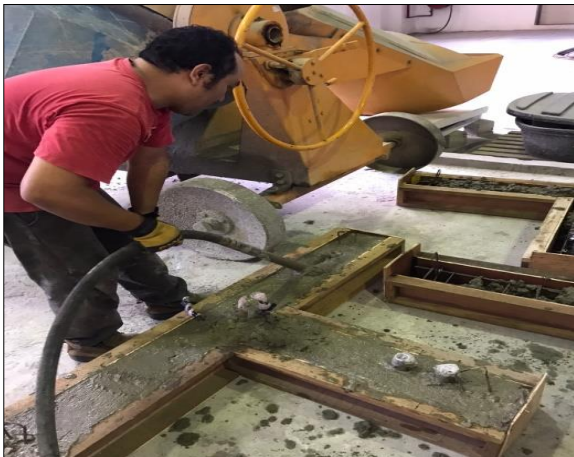
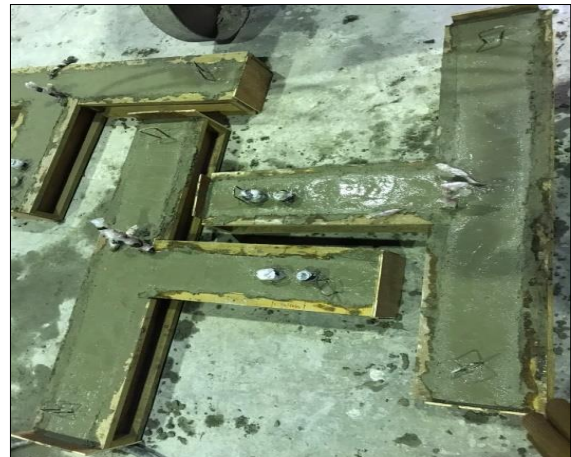
Figure 3. Casting Process of Beam-Column Joints

(a) Installing Reinforcement Bars in The Formwork

(b) Concrete pouring into the formwork

(c) Vibrating Concrete Process

(d) Casting and Curing process of R-ECC

Next, the study proceeds to casting the models of concrete. The concrete grade used in this experiment was G30. Design and preparation came first in the overall process for casting a beam-column joint. Based on the demands of the structural design, the needed dimensions, reinforcing details, and load-bearing capacity of the beam were determined. Figure 3 shows the casting process of the beam-column joint.

The beam-column joint was shaped using mould or formwork. The placement of reinforcement positioned correctly, with a clear covering, and with enough space inside the

formwork, as shown in Figure 3(a). Tie wires or rebar chairs were used to hold the rebars in place to maintain the necessary concrete cover. Subsequently, the blended concrete was gradually poured into the formwork, ensuring a uniform flow to prevent segregation as shown in Figure 3(b). Figure 3(c) shows the vibrators were among the appropriate tools used to compact the concrete and remove air spaces. The entire of the beam's volume was guaranteed to have proper compaction. To achieve the desired finish, the concrete's exposed surface was smoothed with a trowel or float. After that, the samples were cured for 28 days as shown in Figure 3(d), and adequate moisture during the curing process was maintained until the day of testing.

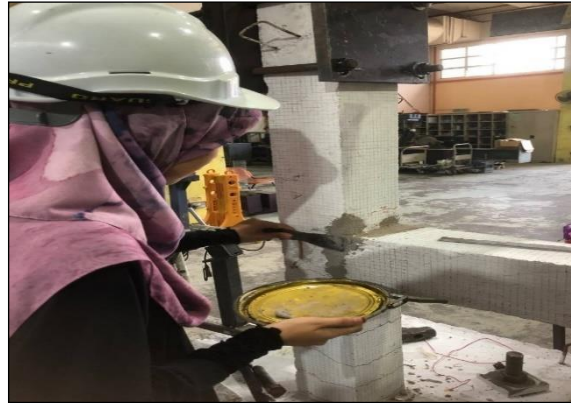
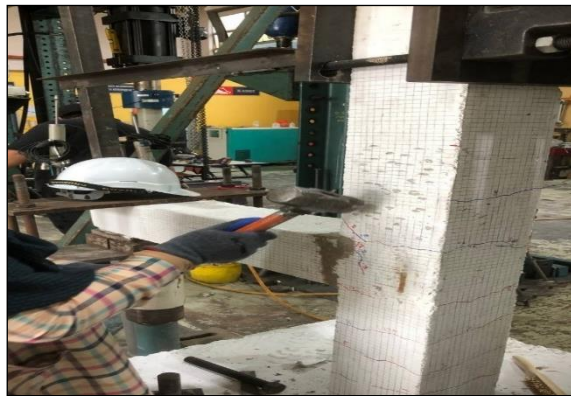
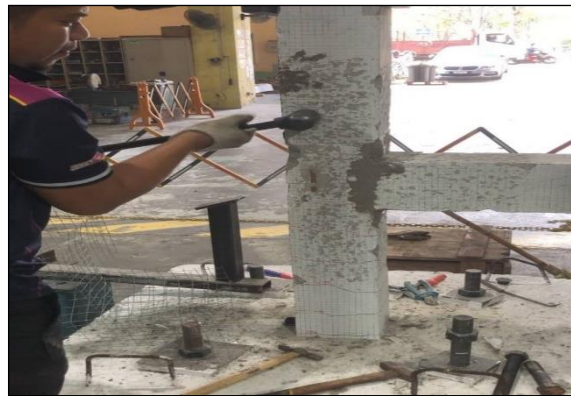
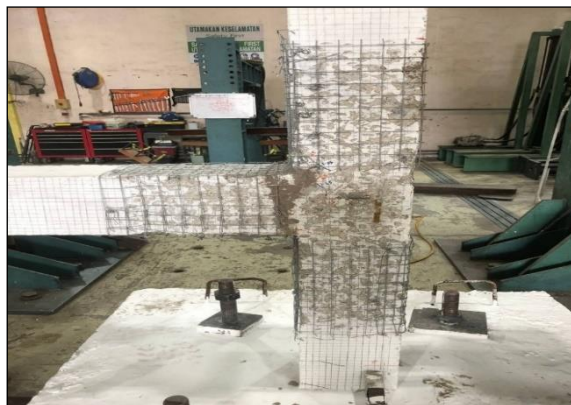
Figure 5. Experimental Work of Beam-Column Joints

(a) Sample After Lateral Cyclic Load Testing

(b) Repairing The Crack Area Using Concrete Seal

(c) Roughness The Surface Using a Sledgehammer

(d) Roughness The Surface Using Impact Hammer

(e) Installing Wire Mesh

(f) Sprayed The Sample with Water to Remove Dust

In the laboratory, beam-column joint component was prepared for lateral cyclic loading. Every beam-column joint unit was put through a test procedure until it broke or failed. Figure 5(a) shows the fracture beam-column joint following lateral cyclic load testing, and Figure 5(b) illustrates the use of a concrete seal to patch the crack location. Sledgehammers and impact hammers were employed to roughen the surface, as seen in Figures 5(c) and 5(d). The goal was to make sure the sample's base lining stuck to it. Figure 5(e) shows the base lining mixing process with a concrete mixer, and Figure 5(f) shows the water spraying of the sample to remove dust. The concrete mixer-mixed base lining mix is shown in Figure 5(g), and the 10 mm thick base lining applied to the affected area is shown in Figure 5(h). Utilising ECC in a line-based ratio, Sika Latex 118 was employed. A base lining was put on the concrete surface. The base lining was used to bond R-ECC to the existing concrete. Next, use a concrete pan mixer to mix for R-ECC, as shown in Figure 5(i). Installing formwork with 20 mm of thickness on the sample and filling the R-ECC into formwork is shown in Figure 5(j). In order to repair and patch concrete bonding with the retrofitted material, R-ECC of 5% was used at the removal area.

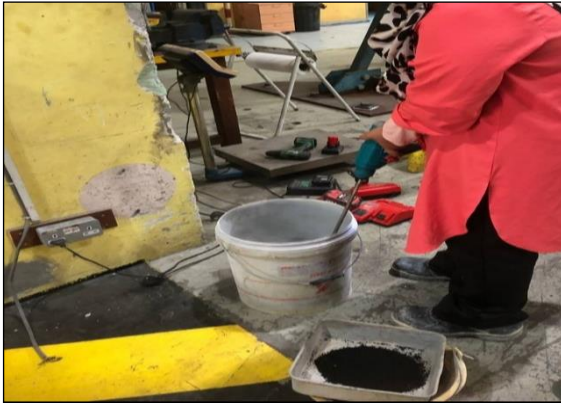
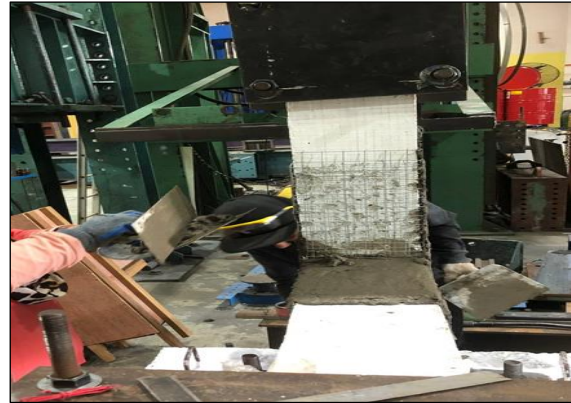
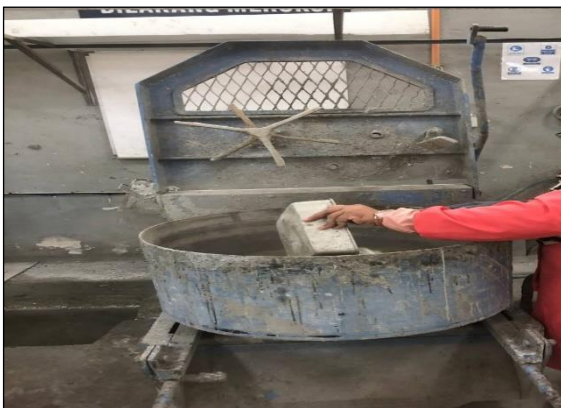
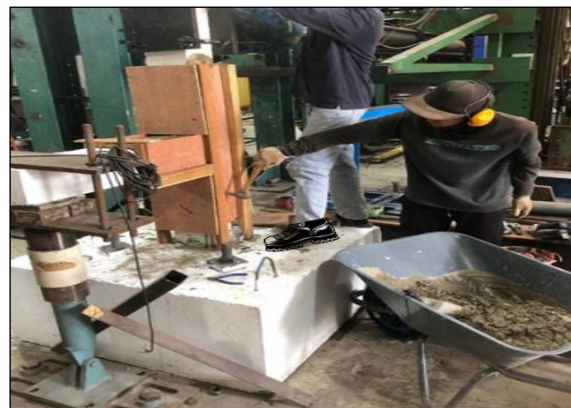
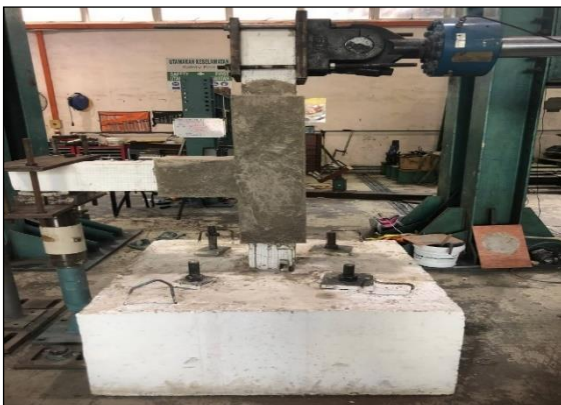
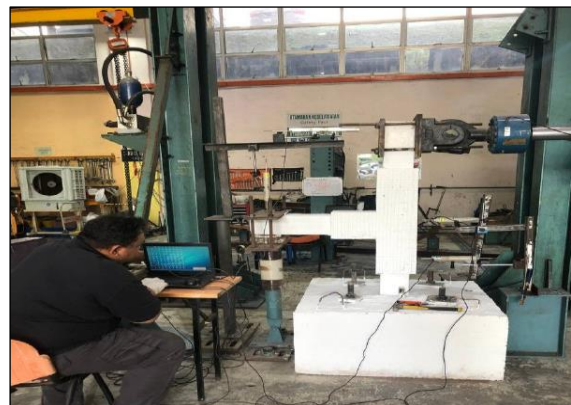
(g) Mix for Base Lining Using Concrete Mixer

(h) Applied Base Lining with 10 mm of Thickness at The Sample

(i) Mix for R-ECC Using Concrete Mixer Pan

(j) Install Formwork and Fill RECC into Formwork with 20 mm of

(k) Open Mould After 24 hours
Apply R-ECC

(l) Testing After Being Retrofitted for
Sample 2

Firstly, the dry components (fly ash, sand, crumb rubber, and composite Portland cement) were added to the pan mixer and blend together. The superplasticiser was added and mixed with half of the water. The remaining water and polyvinyl alcohol (PVA) fibres were gradually added and mixed until a homogenous and uniform mixture was achieved. The mixtures were then cautiously poured into the prepared moulds.

After its placement in the formwork, the R-ECC vibrated. Figure 5(k) shows a sample of the beam-column joint after R-ECC retrofitting. After applying R-ECC for 24 hours the mould was opened. Figure 5(l) shows the testing after being retrofitted for sample 2 using lateral loading frame actuator systems.
