A Preliminary Study on the Slope Failure at Highlands in Peninsular Malaysia

M. Danish Zabidi, B.A. Hadi, Amir K.R., R. Keria, A. Derahman

Faculty of Civil Engineering, Universiti Teknologi Mara Malaysia

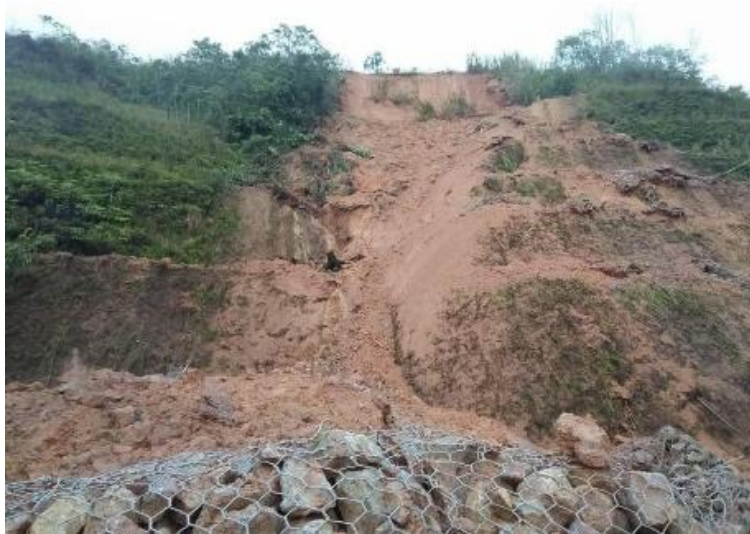
Figure 1. Photo of landslide in 2018 at Kampung Raja, Cameron Highlands
(Source: *Suara Perak*, 2018)

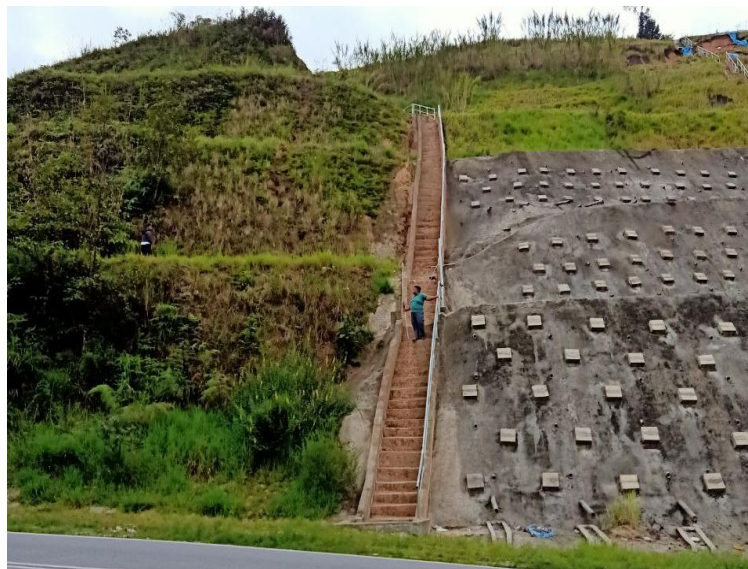
Figure 2. Photo of the site on October 2020

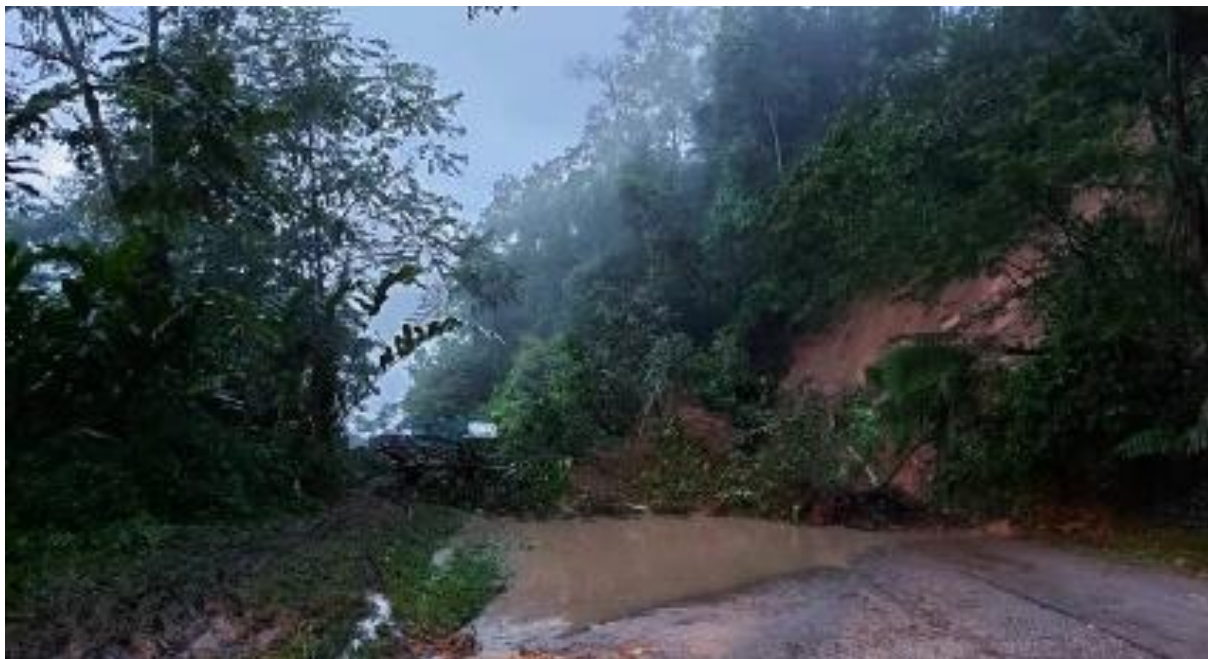
Figure 3. Landslide on October 2020 at Cameron Highlands

Although it remained as a favorite destination especially to local tourist, Cameron Highlands had often been reported for cases of landslides occurrences such in Figure 3. According to Nasidi et al. (2020), the land on Cameron Highlands were made up of two types of soil, mainly podzolic soil and lithosols soil. Yusoff et al. (2016) defined podzolic as type of soil with sandy texture, sensitive to severe degradation by human activities. Meanwhile, Vakilian (1978) defined lithosols as type of soil suitable for growing crops with adequate rainfall. Hadi et al. (2020) indicated that the surface of Cameron Highlands was made up of residual soil consisted of clay.

Hadi et al. (2020) described clay as a binder in maintaining the structure of residual soil. It was further discussed that the clay particles reacted to amount of water it was in contact with. Over exposure of clay with water would result in the form of clay to swell and became spongy. In this condition, the clay binder property would drop, thus weaken the structure of residual soil. The reduction of soil strength would lead to failure in slope stability, which resulted in landslide. This natural disaster was often reported in which an intense rainfall took place such as in Figure 3.

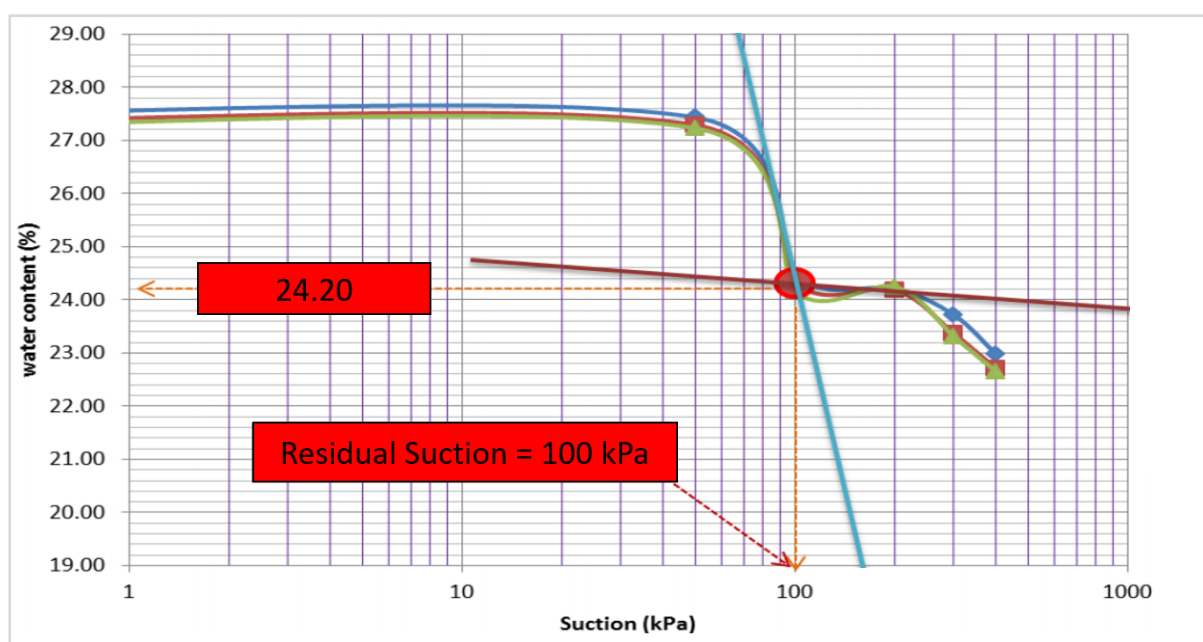
When rainfall occurred, the rainwater would travel along the earth surface as runoff and penetrate into the soil in a process called infiltration. Excessive infiltration due to intense rainfall would lead clay particle in soil structure to swell, resulted in slope failure. A graph of Soil Water Characteristic Curve (SWCC) for granitic residual soil VI by Hadi et al. (2020) in Figure 4 was reviewed following to this phenomenon. Water content was referred as the amount of water contained in soil, measured in percentage (%). While suction was the surface tension force due to capillary and adsorption forces, measured in kilopascal (kPa). Increased in suction resulted in more slope stability. Higher soil strength could be achieved with increased moisture content. The condition remained true until the water content reached 24.2%, where the suction was 100 kPa, as the soil obtained its maximum strength, the slope would achieve its full stability. When more water was added, the soil started to weaken. This would lead to slope failure. Thus, moisture content analysis was required to evaluate the soil strength.

Figure 4. Soil Water Characteristic Curve (SWCC) for Granitic Residual Soil VI
(Source: B.A. Hadi, 2017)

Table 2 shows the result obtained from moisture content analysis. Based on the table, the maximum moisture content obtained was 38.5% while the minimum moisture content was 24.1%. The average moisture content acquired from the analysis was 27.6%. These results were evaluated with the existing model of Soil Water Characteristic Curve in Figure 4.

Based on Figure 4, the strength of soil reduced as the amount of water percentage of soil surpassed its optimum moisture content. Since the average moisture content of samples collected from Kampung Raja exceeded the optimum moisture content of residual soil (27.6% > 24.2%), the location of slope where samples were collected had weaken soil strength.

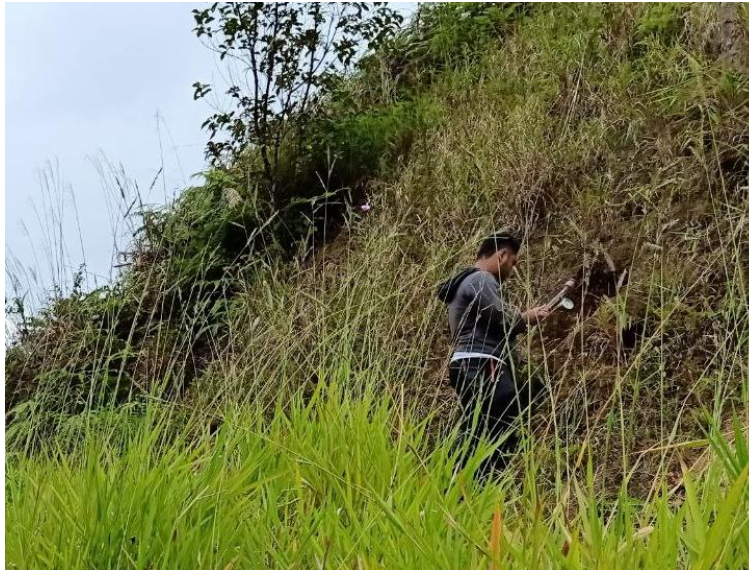
A previously landslide location was chosen for this research. The slope was situated at Jalan Kuala Terla, Kampung Raja, between the route of Simpang Pulai to Cameron Highlands. Depth of 0.2 to 0.5 m from surface of the slope were dug and samples of residual soil were collected as in Figure 5.

Figure 5. Process of collecting soil samples

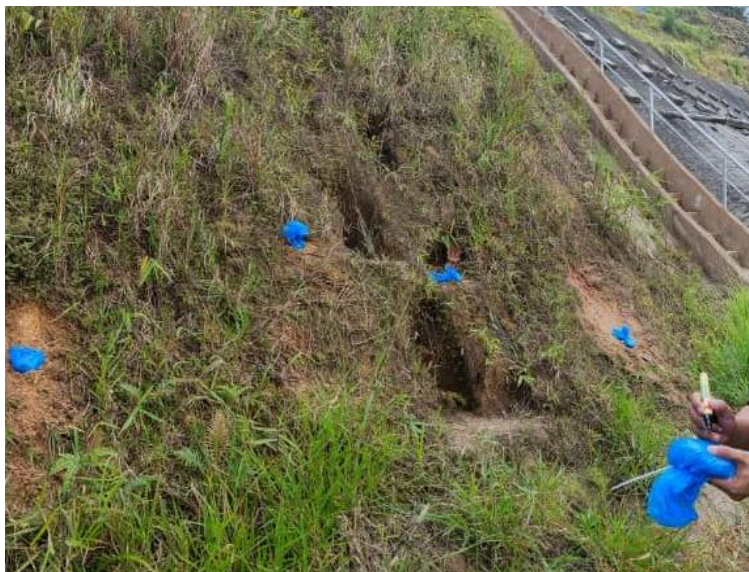
The time and date of each sample were recorded, and their weight were measured using an electronic balance. The temperature and coordinates were also measured by utilizing a Weather software and Google Maps application on smartphone. The details were labelled on the soil samples collected as in Figure 6.

Figure 6. Process of labelling soil samples collected

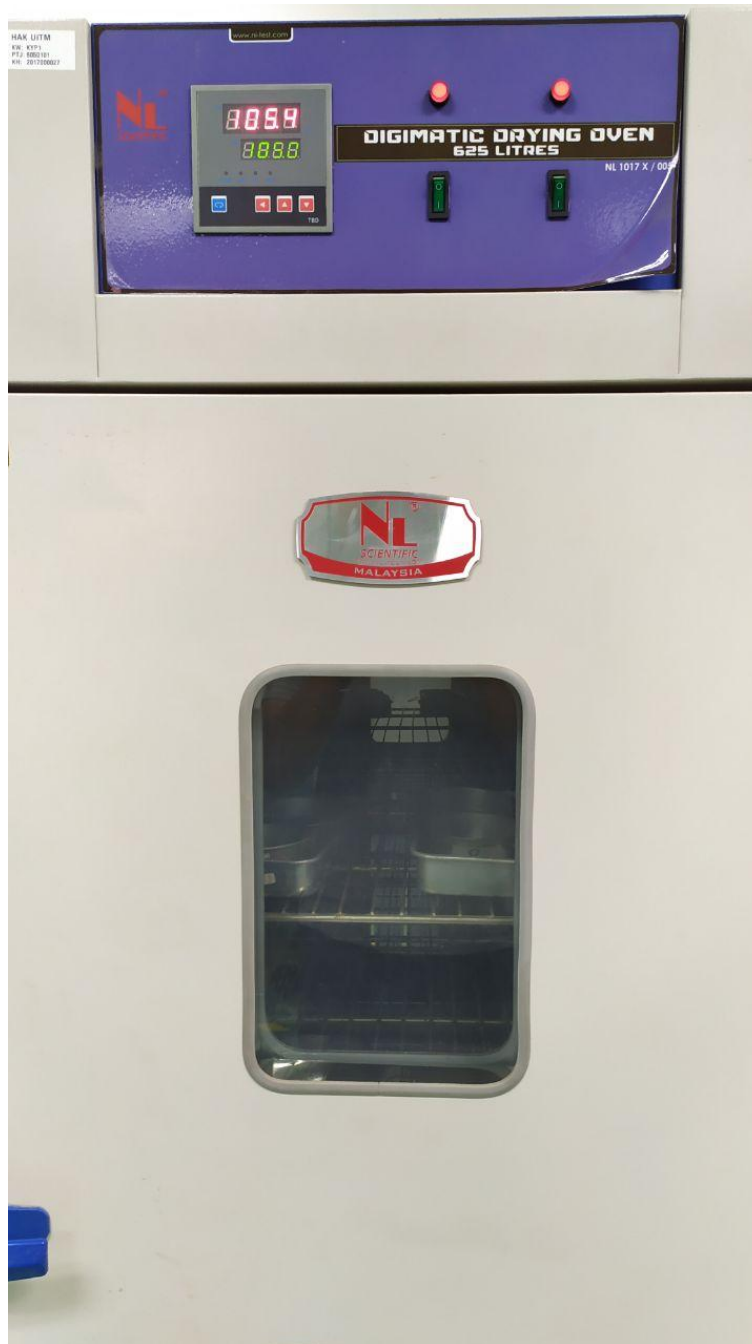
The soil samples were brought to Geotechnical laboratory in UiTM Pulau Pinang and tested with moisture content analysis by oven-dry method in accordance with British Standard 1337: Part 2: 1990: 3.2. Containers were prepared and weighted. Then, soil samples with their individual containers were weighted. They were placed in an oven set at 105 °C for 24 hours as in Figure 7 and later weighted again. The moisture contents of the soil samples were calculated.

Figure 7. Soil samples and containers put in an oven for oven-dry process
