Building Defects in the Coastal Environment of Malaysia: An Investigation of the Main Agents and Contributing Factors

Suriani Ngah Abdul Wahab^{1,2}, Nor Fatimah Rusli¹, Irwan Mohammad Ali^{1,2}, Md Yusof Hamid^{1,2}

Keywords: Environmental, Coastal, Building Defects, Corrosion, Saltwater, Maintenance.

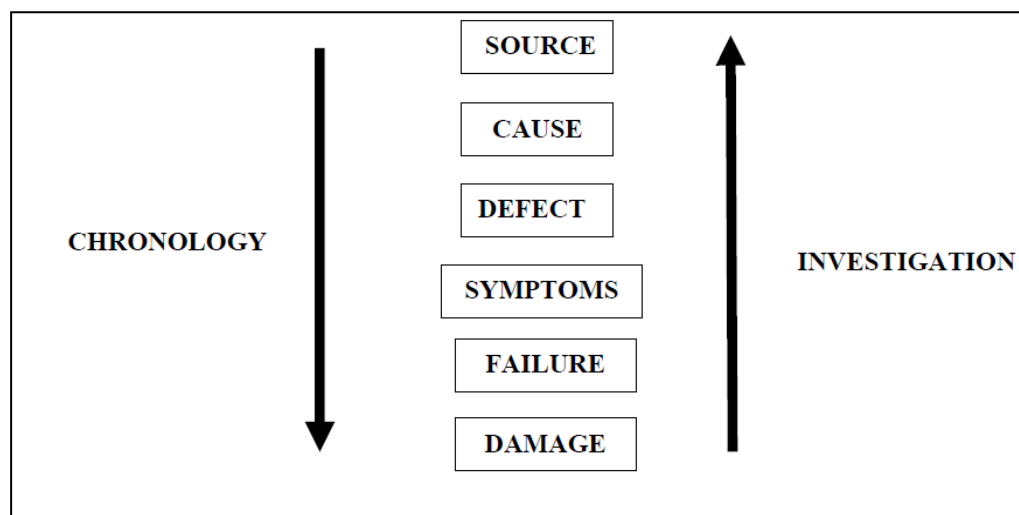
Figure 2 The chronology of investigation (Douglas & Ransom, 2013)

Douglas and Ransom (2013) conducted a chronological study that assisted in the research process as shown in Figure 2. The building's chronology will begin with a source of error that has happened at the structure, which then leads to a cause, which leads to a defect, which manifests as an anomaly or symptom, then failure, and eventually loss or damage (Douglas & Ransom, 2013). The inquiry, on the other hand, will begin with the building damage or failure and work its way to the cause of the defect.

This chronology might assist the researcher in determining the causes and types of defects that developed in the structure. The researcher can also determine what the most serious defect is based on this information. The major purpose of this investigation is to get all necessary information without incurring excessive costs. Additionally, a well-informed decision can be made concerning any recommendations or additional steps that must be taken. This decision should be based on the collected data as well as any potential risks and benefits that may arise.

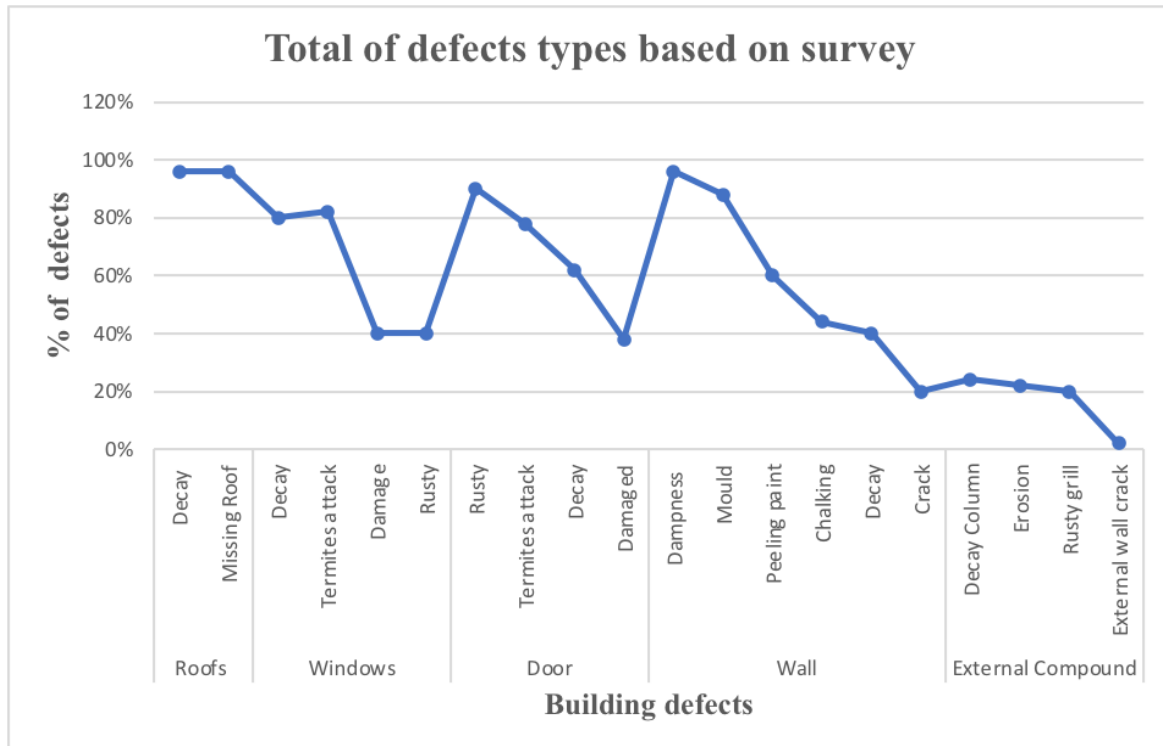
Figure 4 Total of defect based on the survey for coastal environment

Figure 3 and 4 shows the finding of a qualitative survey on building defects and agents that cause them. The finding on the different types of damages that can affect various building components, such as roofs, windows, doors, walls, and external compounds. For roofs, the most common causes of damage are chemical exposure to water and sulphates (96%) and mechanical forces such as wind (96%). Windows are also susceptible to chemical exposure (water and sulphates at 80%), biological damage from micro-organisms (82%), and mechanical forces such as wind (40%). Doors are prone to chemical exposure (water and sulphates at 90%), biological damage from micro-organisms (78% and 62%), and mechanical forces such as wind (38%). Walls can suffer from mechanical forces such as water (96%), biological damage from water and micro-organisms (88%), electromagnetic solar radiation (60%), and thermal climatic conditions (44%). External compounds are mostly affected by biological damage from micro-organisms (24%) and mechanical forces (22%), while thermal/chemical damage from climate conditions and sulphates (20%) is also a factor.

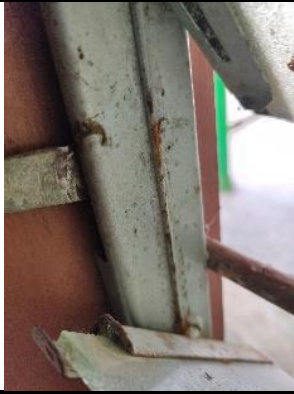
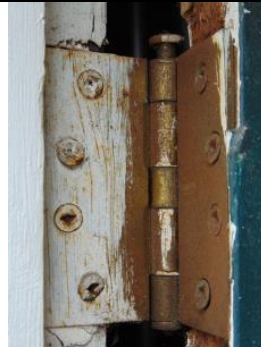
Building 2

Building 1	
Louver windows that have corroded	The door hinge is corroded.

For building 1, the corrosion of louver windows and door hinges in buildings built near the seaside are subject to seawater intrusion. This is a result of the coastal area's wind direction and speed (salt air) affecting the building. The corrosion may have weakened the structural integrity of the affected parts, potentially compromising the safety and security of the building. It is recommended to replace the corroded parts with materials that are more resistant to corrosion in a coastal environment.

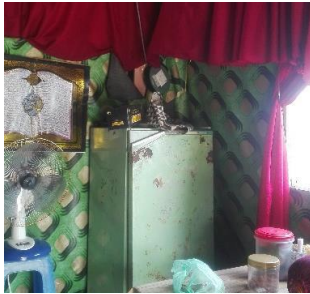
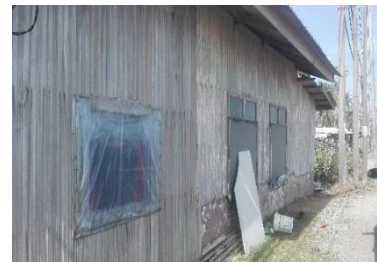
Building 3

Electricity equipment and door hinge corrosion

Meanwhile for Building 2, the corrosion of electrical equipment and door hinges is caused by the exposure of saltwater to electrical appliances in the building. This form of corrosion occurs when two different metals with physical or electrical contact are immersed in a common electrolyte (such as salt water) or when a metal is exposed to different concentrations of electrolyte. When saltwater comes into contact with electrical equipment and door hinges, it can accelerate the corrosion process due to the presence of chloride ions. The seawater that condenses on building elements will finally evaporate, but the salt in the water will remain. This also results in the decay of the timber wall and its surface to be sticky. The sticky surfaces may be due to the salt in the air, which can accumulate on surfaces and make them difficult to clean. It is recommended to repair or replace the affected parts and use materials that are more resistant to corrosion and decay.

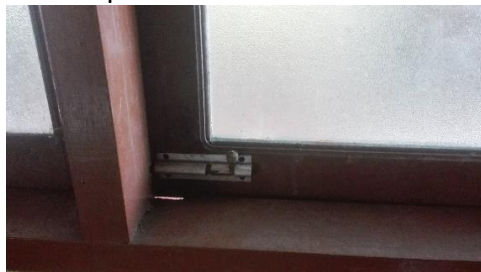
The metal part is rusted.

Wooden structure deterioration and crack

Rust on the metal component and decay of timber structure can be found in Building 4. In the coastal area, the quantity of moisture present in the air is higher than in the deserts. Hence, rusting of iron objects is faster. Biological damage to above-water parts of waterfront structures is caused directly or indirectly by the activity of fungi and insects that utilize wood for food or nesting material. The rust on the metal part can compromise its strength and structural integrity, while the deterioration and crack on the wooden structure may be a result of rot and decay caused by the high levels of humidity and moisture in the air. It is recommended to replace the rusted metal part with a more resistant material and repair or replace the deteriorated wooden structure to ensure the safety and stability of the building.
